**Dewatering of an underground uranium mine in Saskatchewan, Canada**Rashid Bashir<sup>1</sup>, James Hatley<sup>2</sup><sup>1</sup>*Senior Geotechnical Engineer, Golder Associates, 1721 8th Street East, Saskatoon, Saskatchewan, Canada S7H 0T4, rbashir@golder.com*<sup>2</sup>*Director, McArthur River Extension, Major Projects Division, Cameco Corporation, North 48 Centre, 838 – 48th Street East Saskatoon Saskatchewan, Canada S7K 3Y4, james\_hatley@cameco.com***Abstract**

The Cigar Lake Project is an underground uranium mine under construction in Northern Saskatchewan, Canada. The test mining program at Cigar Lake Project demonstrated the effectiveness of artificial ground freezing to control water inflows. However an inflow event occurred on October 26<sup>th</sup> 2006 on the 465 level of an unfrozen section of the development. The inflow was hypothesized to be result of the of ground failure of a relatively thin (about 8 m) beam of weak, fractured rock exposed in the roof of the drift and being loaded from above by relatively high hydrostatic pressure (about 4.2 MPa). The mine was flooded as the result of the inflow event. This paper documents the various activities of remediati

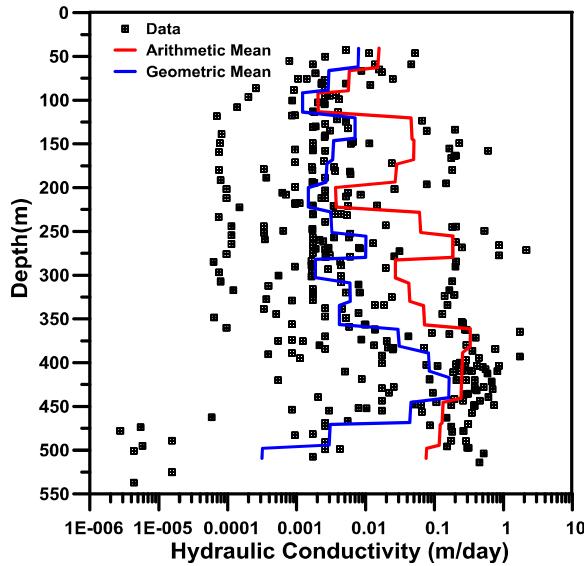
The sandstone outside the ore zone is the typically unaltered Athabasca Sandstone, which is approximately 450 m thick. Based on the vertical distribution of the hydraulic conductivity values derived from the packer tests, the lower portion of the sandstone is generally more permeable than the upper portion (Figure 1). Therefore, the unaltered sandstone can be divided into upper and lower sandstones, with the latter more permeable. This is a rather unusual relationship of hydraulic conductivity with depth (the norm being a decrease with depth). A possible explanation this increase is that they are a result of the fluids that moved through them and above the unconformity as part of the ore-forming process. The hydraulic heads from various multi-level piezometers indicate that the hydraulic heads on the south side of the ore zone are generally higher than the hydraulic heads on the north side of the ore zone resulting in groundwater flow direction in the sandstone to be from south and southwest toward the northeast.

**Figure 1** Variation of hydraulic conductivity with depth.

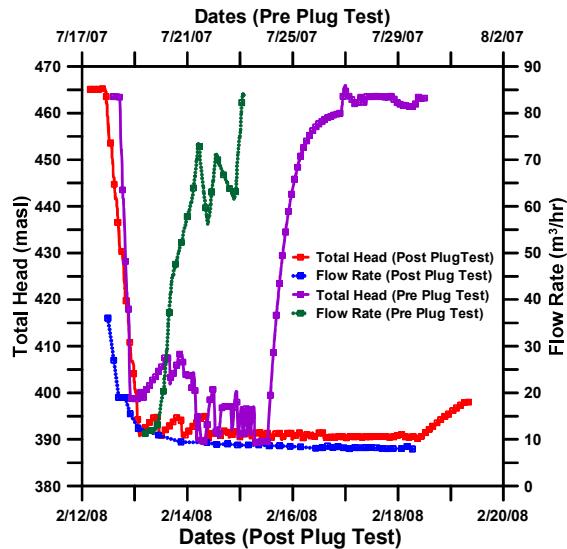
**Figure 2** Results from pre and post plug tests

constant at this level and inflow to the mine workings under the imposed head was estimated by measuring the volume of water that needs to be pumped out to maintain the water level. The estimated amount of inflow to the mine workings was compared to a similar drawdown test done prior to the installation of the concrete plug. Figure 2 shows that results from pre and post plug drawdown tests. From this figure it can be seen that the installation of plug resulted in reduction of inflow to the mine workings by almost 89% under the imposed head. Following the drawdown test, a decision was made to dewater the mine in increments.

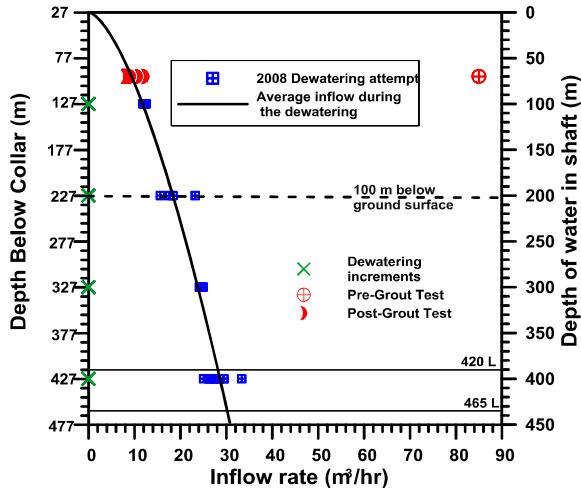
The water from the mine workings was pumped out in increments with the water level held constant for a period of time at predetermined intervals. The water level was held at these predetermined intervals to estimate the amount of inflow as the head on the workings was increased and to provide enough time for the excess pore pressure to dissipate. The rate for dewatering the mine (the rate at which head was applied to mine workings/rate at which water level was lowered) was decided after a detailed geotechnical stability study by a third party geotechnical expert. Figure 3 shows the inflow rates estimated during the dewatering attempt. The projected inflow to mine workings under fully dewatered conditions was slightly in excess of the pre inflow value.

**Figure 3** Flow rates for the 2008 dewatering.

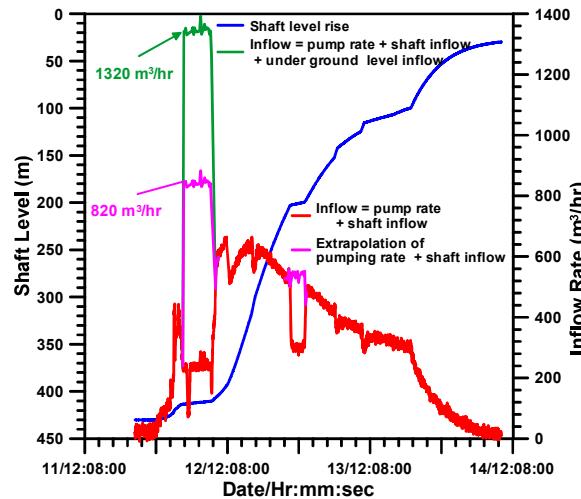
The dewatering attempt was suspended on August 12, 2008 when the rate of the inflow to the mine significantly increased when the water level was held constant at 430 m below surface. Figure 4 shows the shaft water level rise in the shaft # 1 and the associated calculated inflow rates to the mine workings. The inflow rate was calculated by the summation of pump rates and volume of water required to raise the water level in the shaft # 1. In Figure 4 it can be observed that estimation of flow rate in this manner results in reduced inflow estimates as the 410 and 210 levels were reflooded. Fairly accurate estimates of the underground mine volumes at 210 and 420 levels were available. Taking into consideration the additional amount of inflow required to fill the underground levels resulted in estimates that indicated that as the water level rises to the 420 level the inflow rate increased from approximately 400 m<sup>3</sup>/hr to approximately 1320 m<sup>3</sup>/hr. This fourfold increase in inflow rate was found to be anomalous as post 420 level flooding inflow rate was approximately 600 m<sup>3</sup>/hr. The fourfold increase in inflow at the start of the 420 level flooding and then its reduction post flooding was not supported by the piezometer data recorded close to the mine workings.

**Figure 4** Shaft water levels and flow rates for 2008 inflow

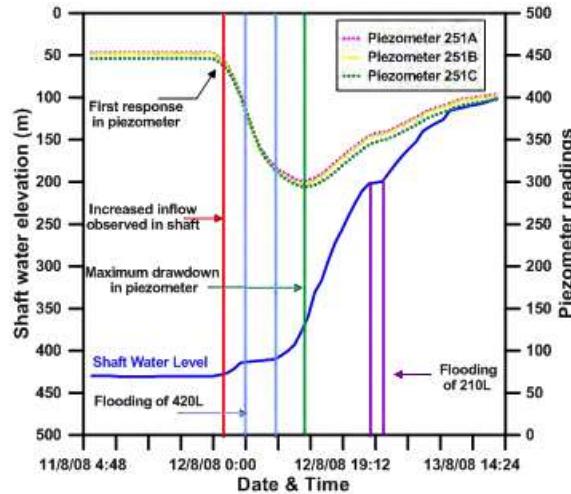
Figure 5 provides a time line of the inflow event, the time of flooding of 420 and 210 levels are clearly marked. A close look at the multi-level piezometers readings indicates that, at the onset of the inflow a response can be observed before any increased inflow was observed in the shaft # 1. However, if the inflow rate would have suddenly increased fourfold at the time when water level reached 420 level, a sudden change in piezometer readings should have been observed. The piezometer readings neither support an increase in flow rate at the start of the 420 level flooding nor inflow rate reduction post 420 level flooding.

**Figure 5** Timeline for 2008 inflow event

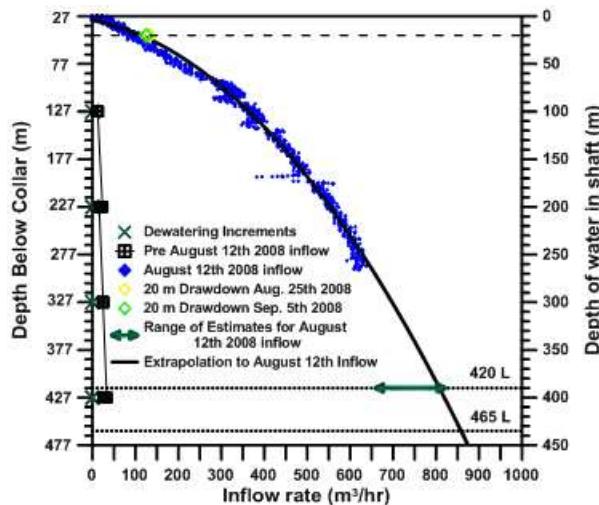
Figure 6 shows the inflow rate calculated as the summation of the pumping rate and volume required to raise the water level in the shaft as a function of shaft water level. Extrapolating the inflow data by fitting a 2nd degree polynomial (coefficient of determination  $R^2$  of 0.99), it was estimated that the water inflow rate could potentially be approximately  $820 \text{ m}^3/\text{hr}$  when the shaft # 1 water level was drawn to 430 m level. Two 20m drawdown tests conducted post the 2008 inflow event are also shown in the same figure and plot directly over the data collected during the inflow event. The extrapolated inflow rate is also plotted in Figure 4 and it can be observed that even this increase of inflow rate during the

420 level flooding seems unlikely when piezometer readings from Figure 5 are taken in to consideration. Therefore it was hypothesized that the inflow rate during the inflow event was in the range of 660 to 820 m<sup>3</sup>/hr.

**Figure 6** Extrapolation of the 2008 inflow data

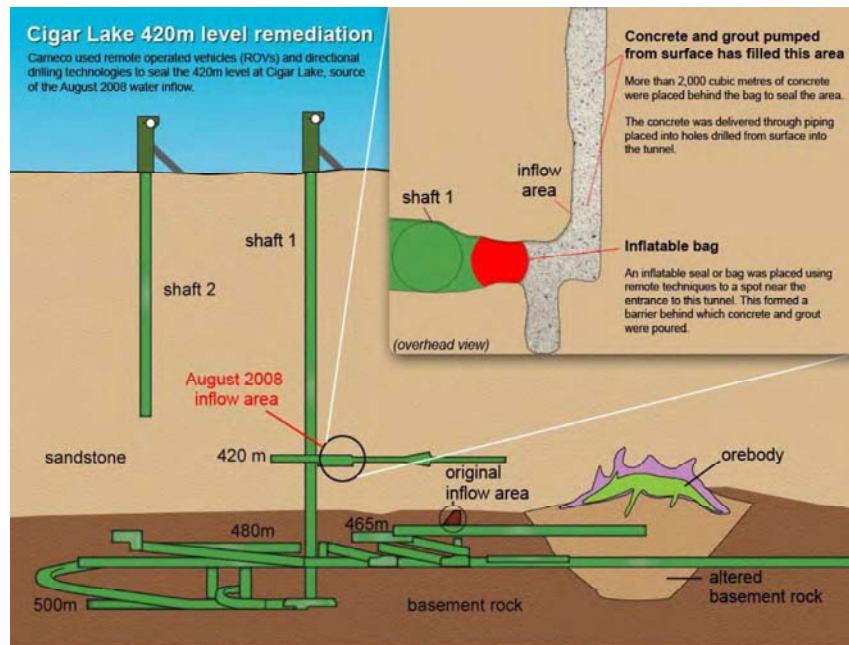
**Figure 7** Cigar Lake remediation plan - August 2008 water inflow

Unlike the 2006 inflow, the location or cause of the August 2008 inflow was not immediately known. As part of the assessment, drawdown tests at staged intervals were carried out. Submersible remotely operated vehicles (ROVs) were used to conduct visual inspections of water flows and temperature changes inside the mine during draw-down tests to track down the inflow source. The source of inflow was identified as a fissure located in a tunnel on the 420 m level. The 420 m level was developed in sandstone in the early stages of the project to assess the practicality of developing a working level above the orebody. Further development on the 420 m level proved not to be feasible due to poor ground conditions. A phased recovery plan to seal the 420 m level and remediate the shaft workings was developed. Using ROVs, access to the inflow area was secured by dredging sediment and removing equipment. A bulkhead was placed in the tunnel where the inflow occurred using a specially designed high strength bag that was positioned using ROVs and then filled with grout pumped from the surface to block the tunnel (Figure 7). Once the bag was fully inflated, concrete was pumped through drill holes from surface to backfill the development behind the seal with concrete and grout.

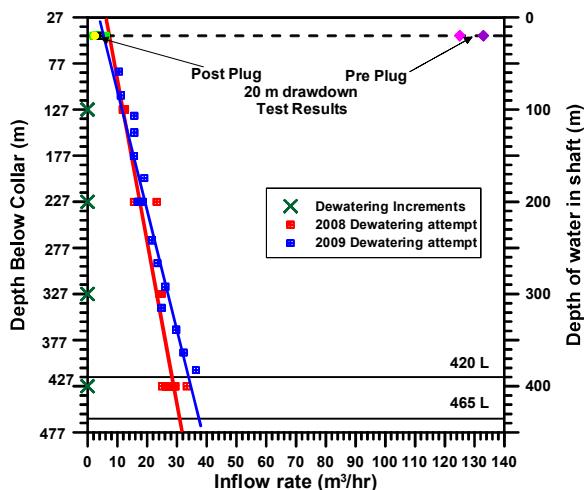
Following the installation of the plug, drawdown tests were conducted to estimate the amount of inflow to the mine workings. The water level in the shaft # 1 was drawn down by 20 m and held constant over a period of time. The inflow rates were determined by estimating the volume of the water that needed to be pumped out to maintain the water level constant in the shaft. A comparison of the inflow rates from these tests with tests performed before the installation of plug are shown in Figure 8, this indicates an order of magnitude decrease in inflow rates for a drawdown of 20 m.

Consistent with the previous dewatering attempt the water from the mine workings was pumped out in increments with the water level held constant at for a period of time at predetermined intervals. The inflow rate at each of these predetermined intervals is shown in Figure 8 along with the results from 2008 dewatering. It can be observed inflow rates from the current attempt match closely to the previous attempt before the development of inflow at 420 level. The mine was successfully dewatered.

**Figure 8** Data for 2008 inflow remediation and 2009-2010 dewatering
